This Service Information bulletin supersedes S.I. 72 04 96 dated April 1996 which should be removed and discarded from your S.I. binder.

SUBJECT: Fault Codes 16/17 or 24/25 in SRS Control Module

MODEL: 3 Series (E36), 5 Series (E34, E39), 7 Series (E38), 8 Series (E31)

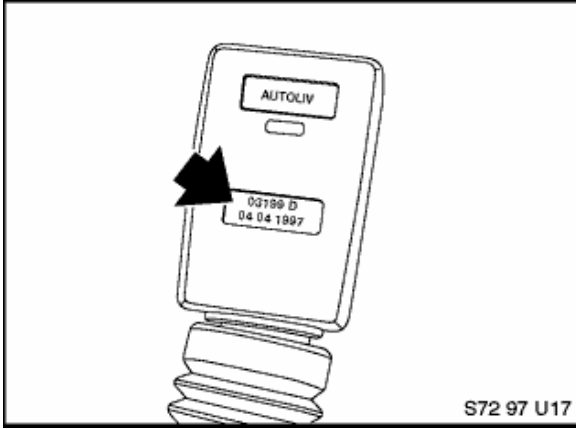
The safety belt latch with the latest improvements to the mechanical microswitch can be identified by the date **04.04.1997** or higher, stamped on the receptacle housing.

Part manufactured after 04.04 1997

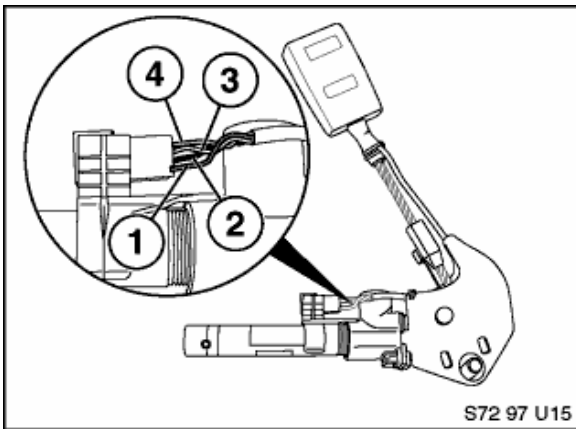
The improved parts can be recognized in all models by the 4 pin, 4 wire connector (additional red wire supplies power to the Hall Effect sensor).

Four wires on the safety belt buckle side=Hall Effect Sensor.

- 1 - Red
- 2 - Black
- 3 - Grey
- 4 - Brown

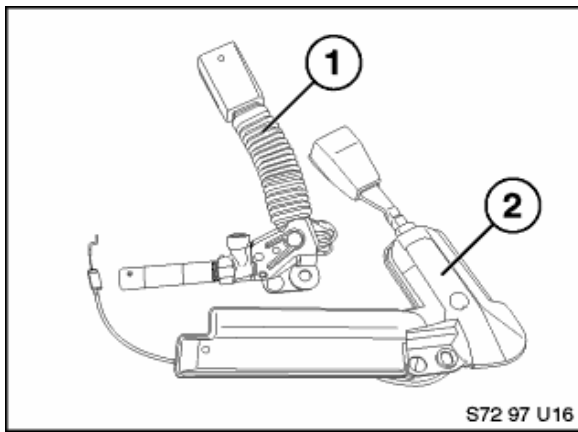
- 1 E36 belt buckle with pyrotechnical tensioner
- 2 E36 belt buckle with mechanical tensioner

Important Since March of '97 production, all E36 models are fitted with the pyrotechnical tensioner units which replaced the mechanical type. In case of replacement only safety belt buckles with pyrotechnical tensioners must be used on those vehicles (P/N 72 11 8 221 013, and P/N 72 11 8 221 014).
